RE: **Asbestos Survey Report**
Proposed McDonald's
1000 S. Main Street
Salem, Missouri 65560
PSI Project Number 0029-5500

ASBESTOS SURVEY REPORT

**PROPOSED MCDONALD'S
1000 S. MAIN STREET
SALEM, MISSOURI 65560**

PSI PROJECT NUMBER 0029-5500

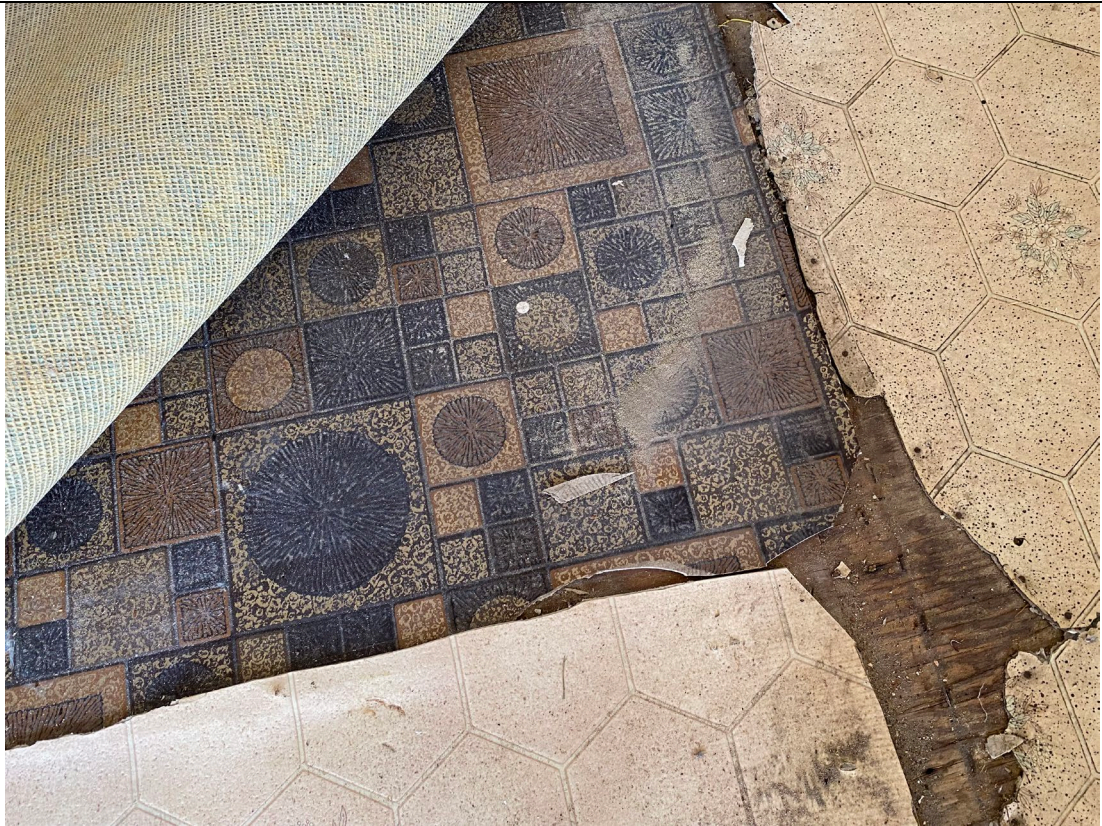
PHOTO 1

View of ACM Floor Sheeting in Office Storage Room

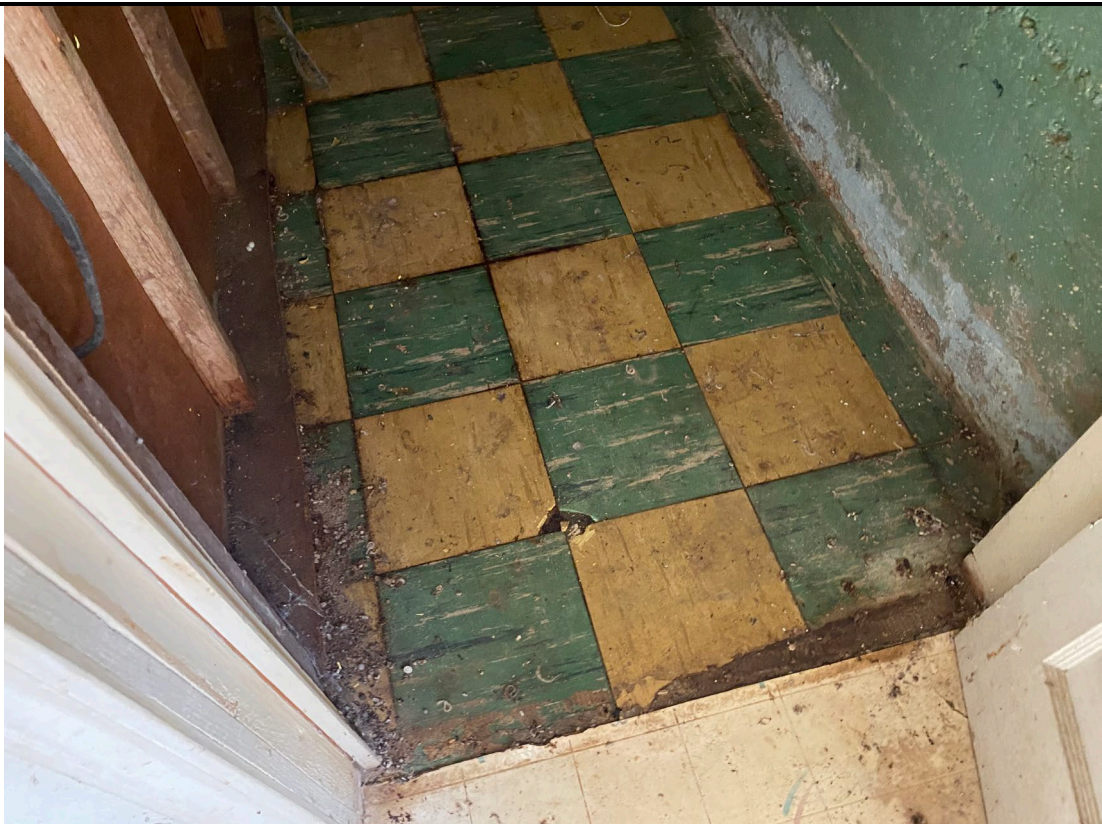
PHOTO 2

View of multi-layered ACM Floor Tile and Mastic – Lower Level Common Room, Rooms 131, 132, 133, 134, Lower Level Storage Room #2

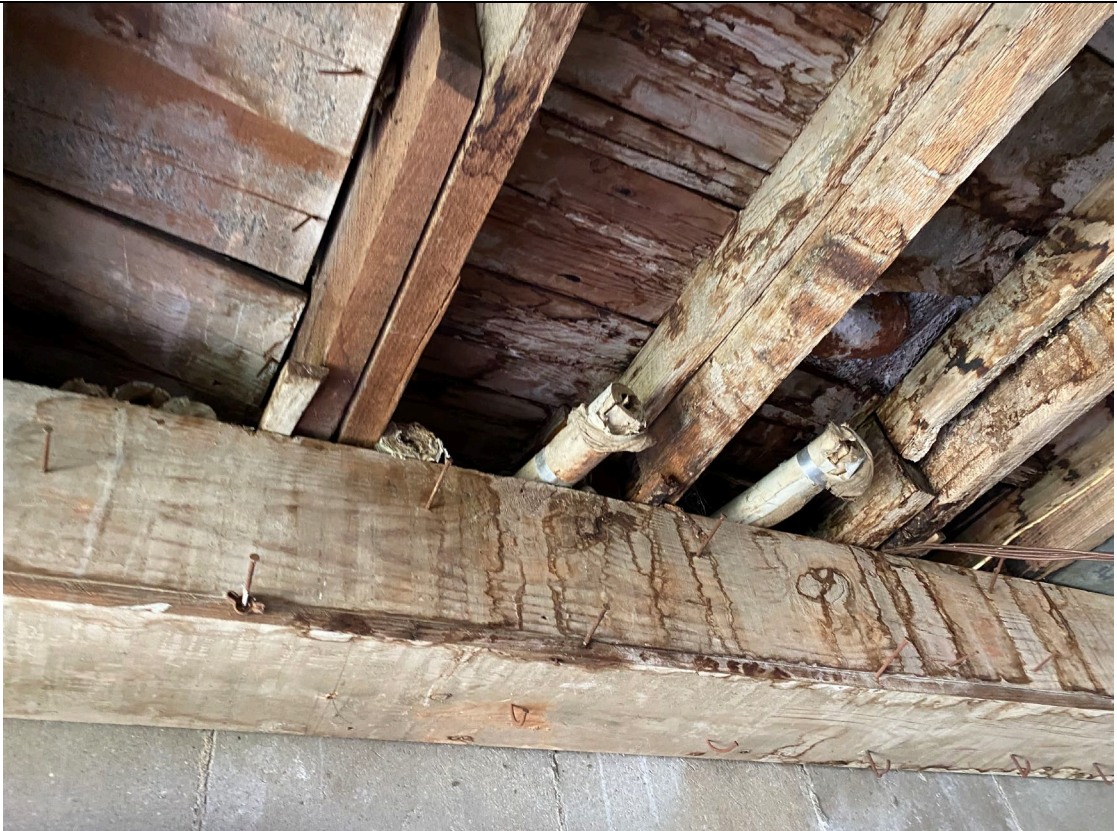
PHOTO 3

R	01 02 03	Pipe and Pipe Fitting Insulation	Throughout various areas of the LL	30% CH	F	Friable	100 LF *observed (500 LF assumed above drywall ceiling in LL)
S	01 02 03	(1) 12" by 12" Floor Tile, beige (2) Mastic, black	Room 134 Restroom	(1) 3% CH, 3% CH, 3% CH (2) NAD	NF	Cat. 1 NF	25 SF
T	01 02 03	Floor Sheeting	Room 139	NAD	F	N/A	N/A
U	01 02 03	Window Glazing	Windows Throughout	NAD	F	N/A	N/A
V	01 02 03	Roofing Shingles	Roof	NAD	NF	N/A	N/A
W	01 02 03	2' by 4' Ceiling Tile	Rooms 141, 144	NAD	F	N/A	N/A
X	01 02 03	Floor Sheeting, tan	Room 144	NAD	F	N/A	N/A

View of ACM Pipe Insulation

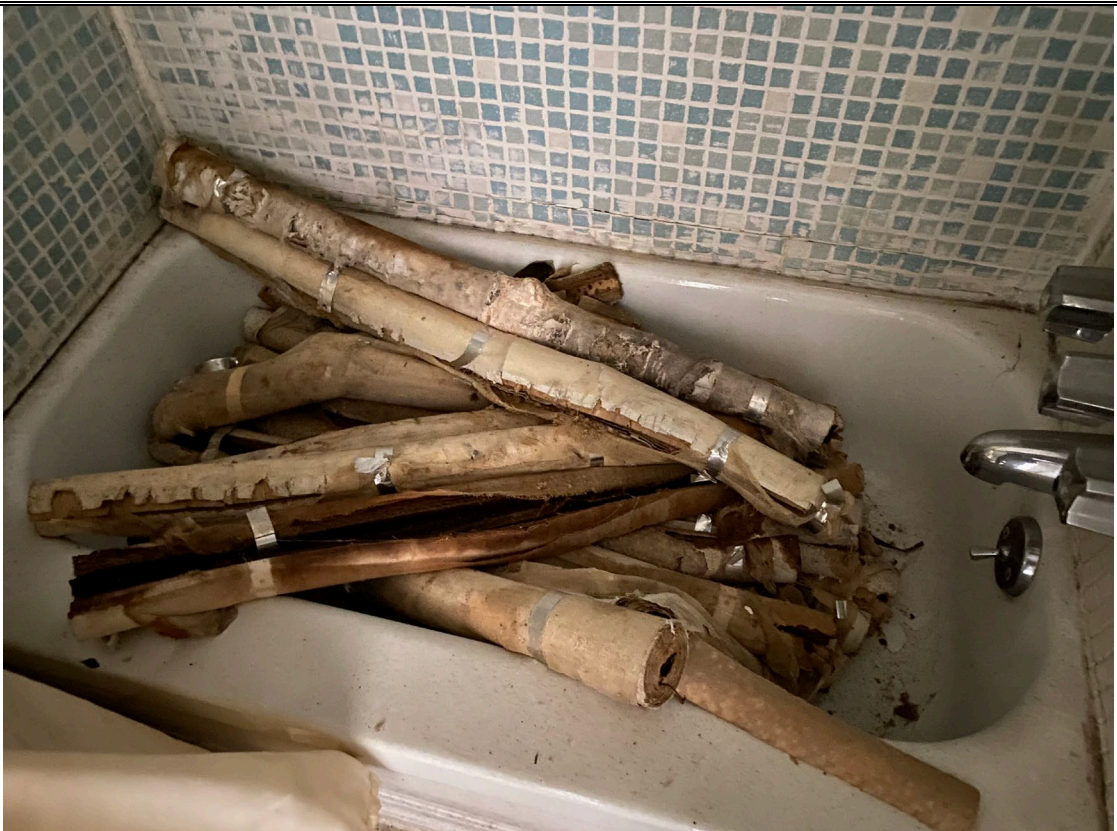
PHOTO 4

View of ACM Pipe Insulation as debris/garbage

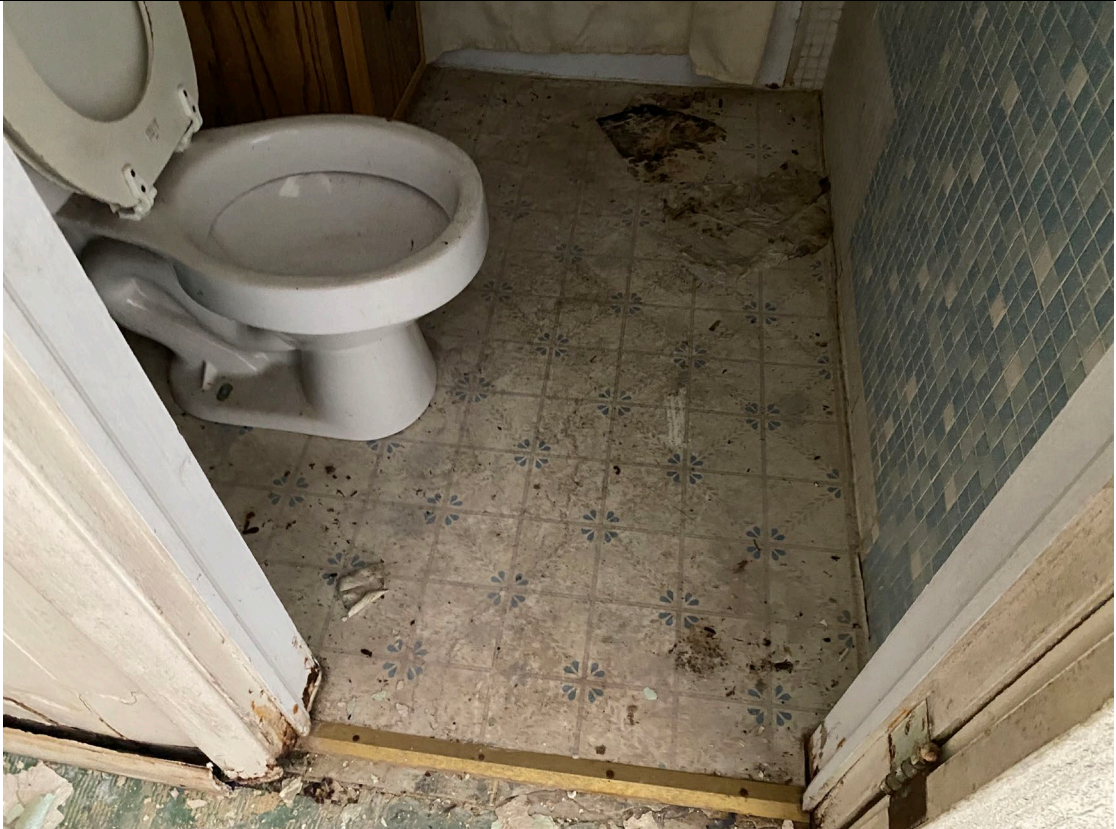
PHOTO 5

View of ACM Floor Tile in Restroom of Room 134
